**First Five-Year Review Report
for
Ritari Post and Pole Superfund Site
Sebeka
Wadena County, Minnesota**

September, 2003**PREPARED BY:**

**Minnesota Pollution Control Agency
520 Lafayette Road N.
St. Paul, Minnesota 55155**

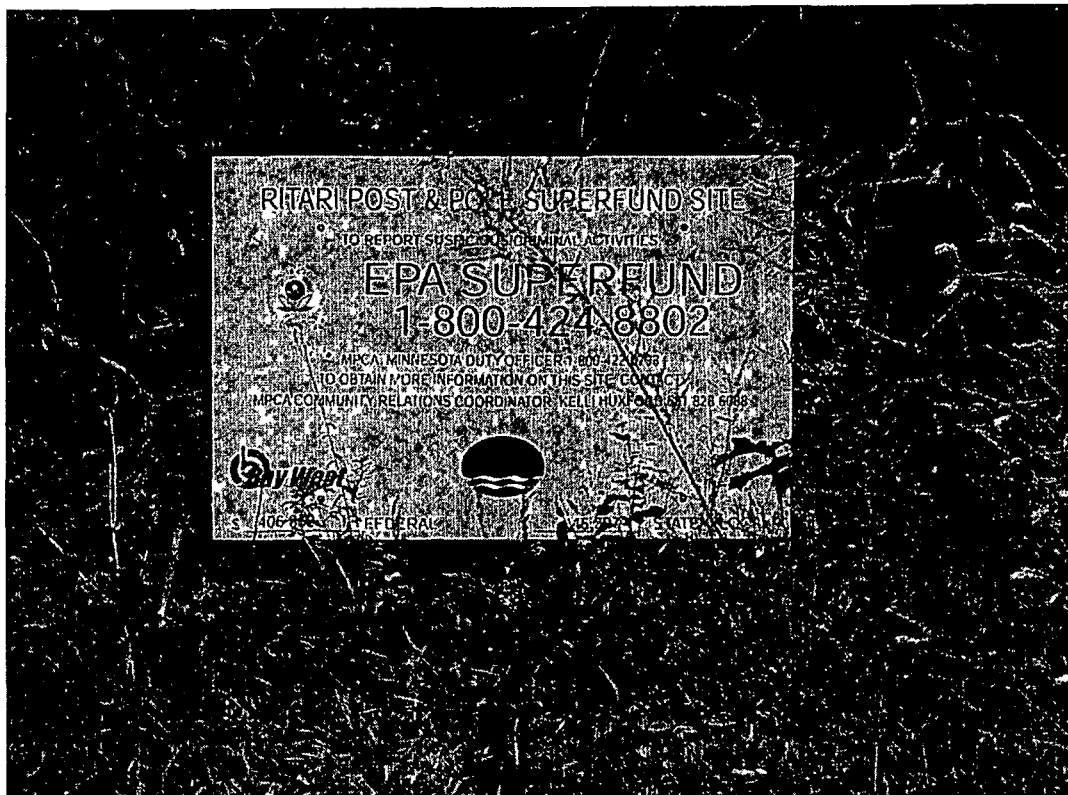
B. Other Access Restrictions																																							
1	Signs and other security measures <i>Location shown on site map</i> Remarks: <i>Good Condition but not easily visible from road</i>	N/A

4) Identification sign

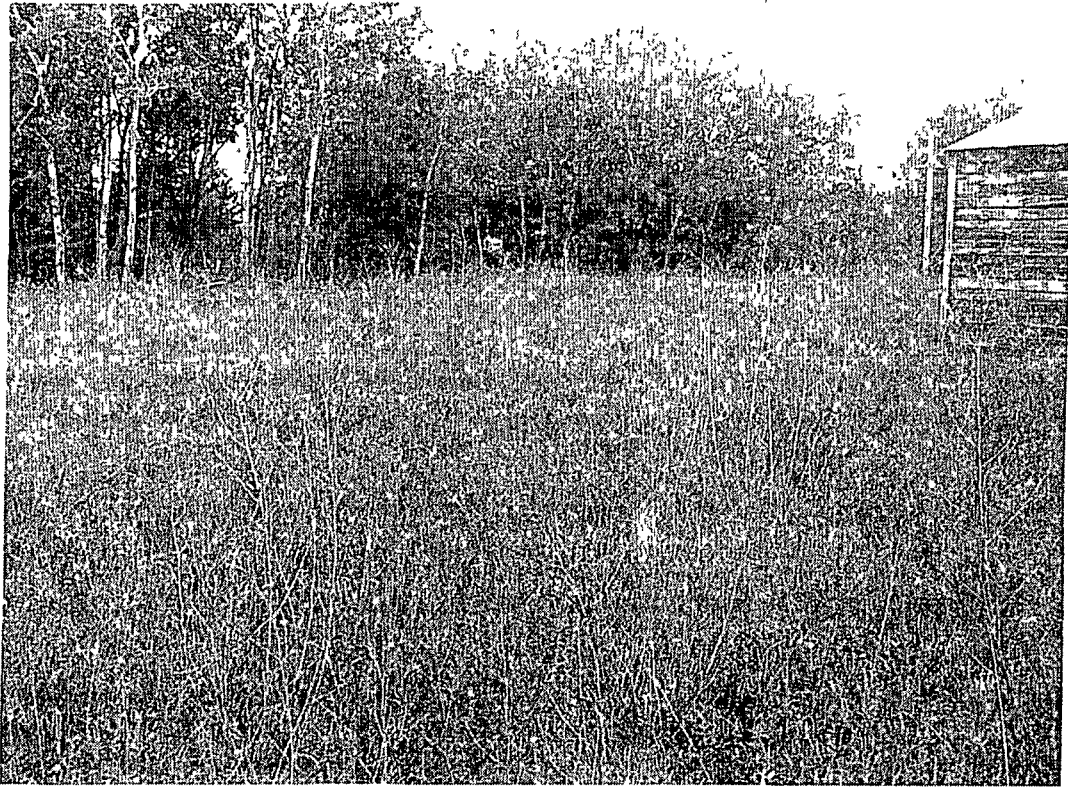
5) View of vegetation growth in former excavation area south of cap.

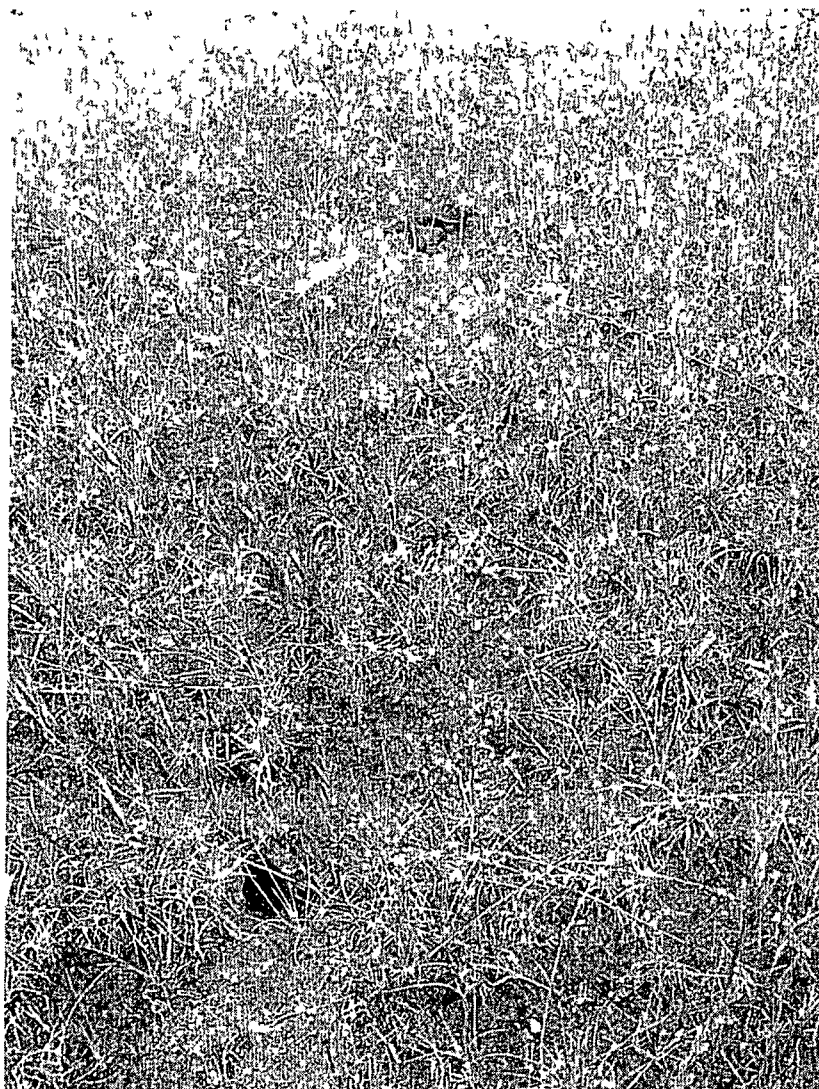
Several minor issues have been identified for the Site. Examination of the cap revealed that there had been some burrowing of small animals. A small crack along the surface of the cap was noted. Several areas of sparse vegetation on the cap coinciding with slight topsoil erosion were also documented. Additionally, some monitoring wells and piezometers not on the current monitoring list could be considered for abandonment if they will not be used again in the future. Specifically, as documented in the photographs and checklist, monitoring well MW-14U has experienced significant frost heaving resulting in an unstable casing above the surface. The Site Inspection Checklist and photographs taken during the Site visit are provided in Attachment 4.

15) Animal holes on surface of cap.

- 1) Repair current burrows and cracks and revise the O&M repair task to ensure future burrows and cracks are identified during the Site visits and repaired.
- 2) Re-seed areas of topsoil with sparse vegetation and rake over and repair areas with minor erosion as necessary.
- 3) Install a sign near access gate on fence around cap to warn against unauthorized access or entry.
- 4) Abandon monitoring wells and piezometers not on the current ground water monitoring list, if they will not be used again in future monitoring events.
- 5) Address remaining potentially impacted soil to assure no exposure pathway and to prevent contaminants from further leaching into the ground water at the Site.
- 6) Implement institutional controls to prevent future ground water development and prevent exposure to contaminants in soils at the Site.

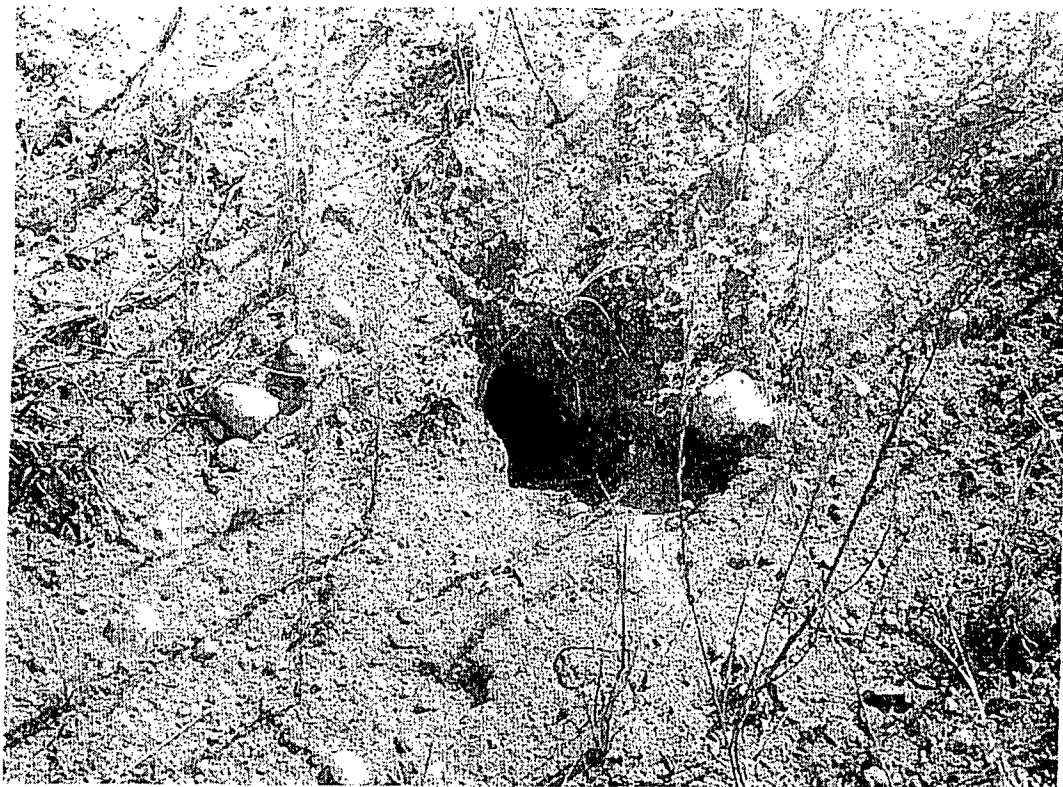
16) Close-up of an animal hole on surface of cap.

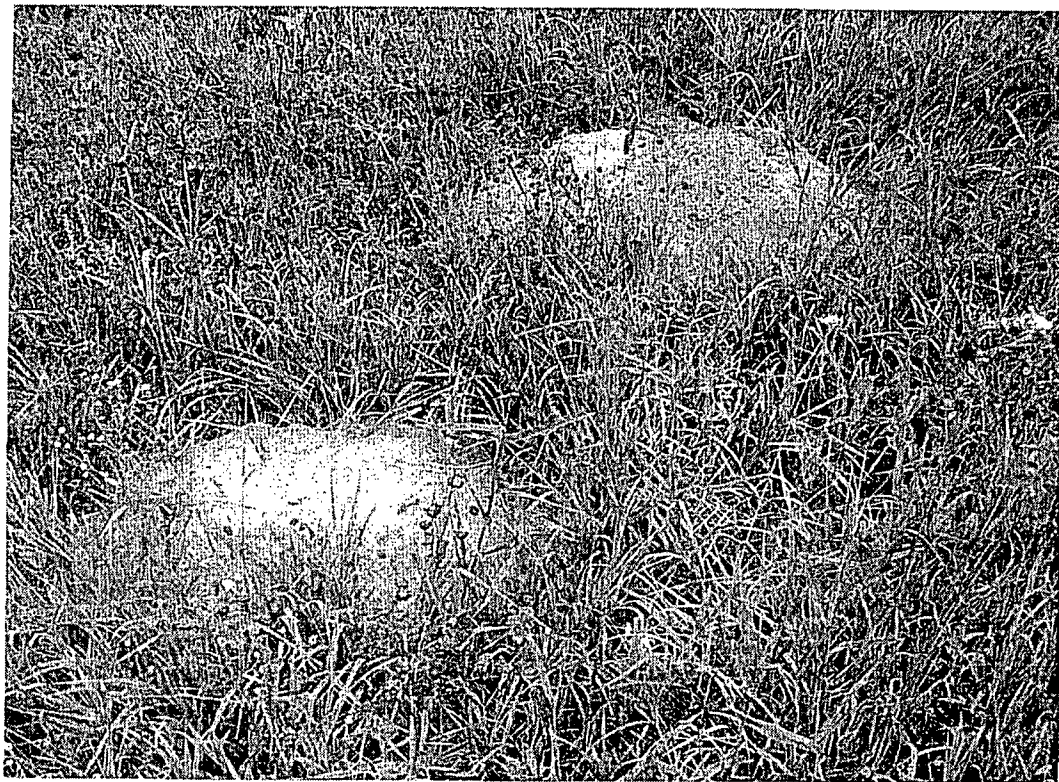
17) Gopher mounds on surface of cap.

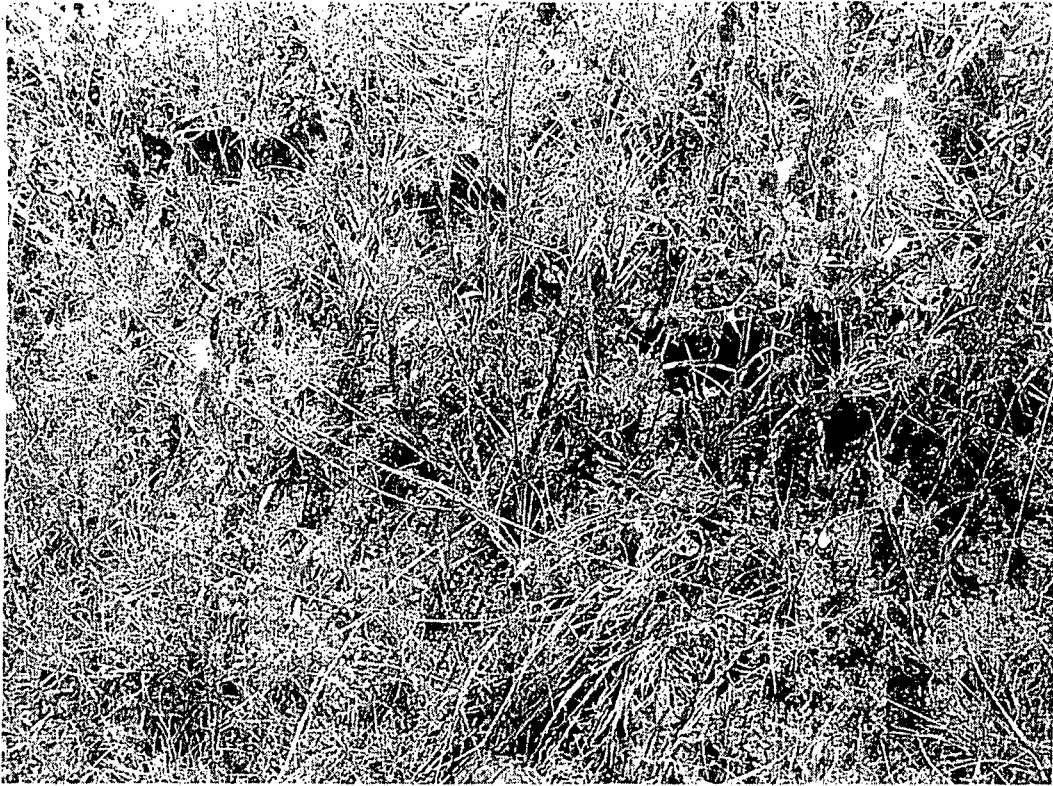
18) Close-up of a small crack observed on surface of cap.

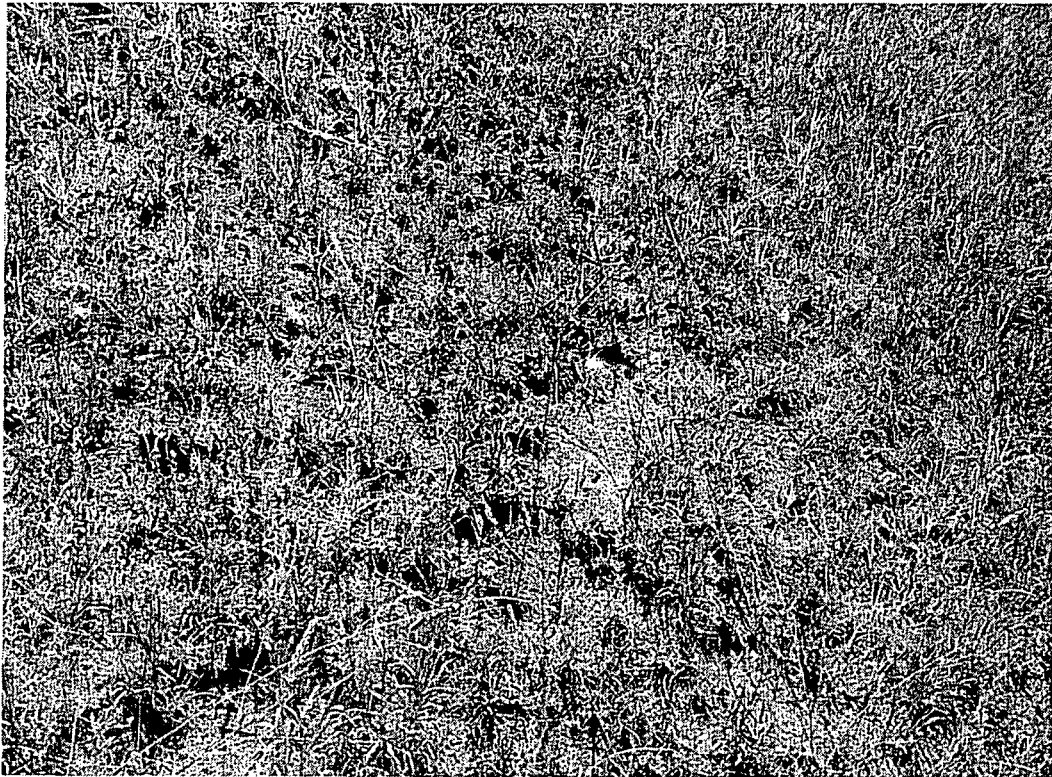
19) View of sparsely vegetated area on surface of cap.

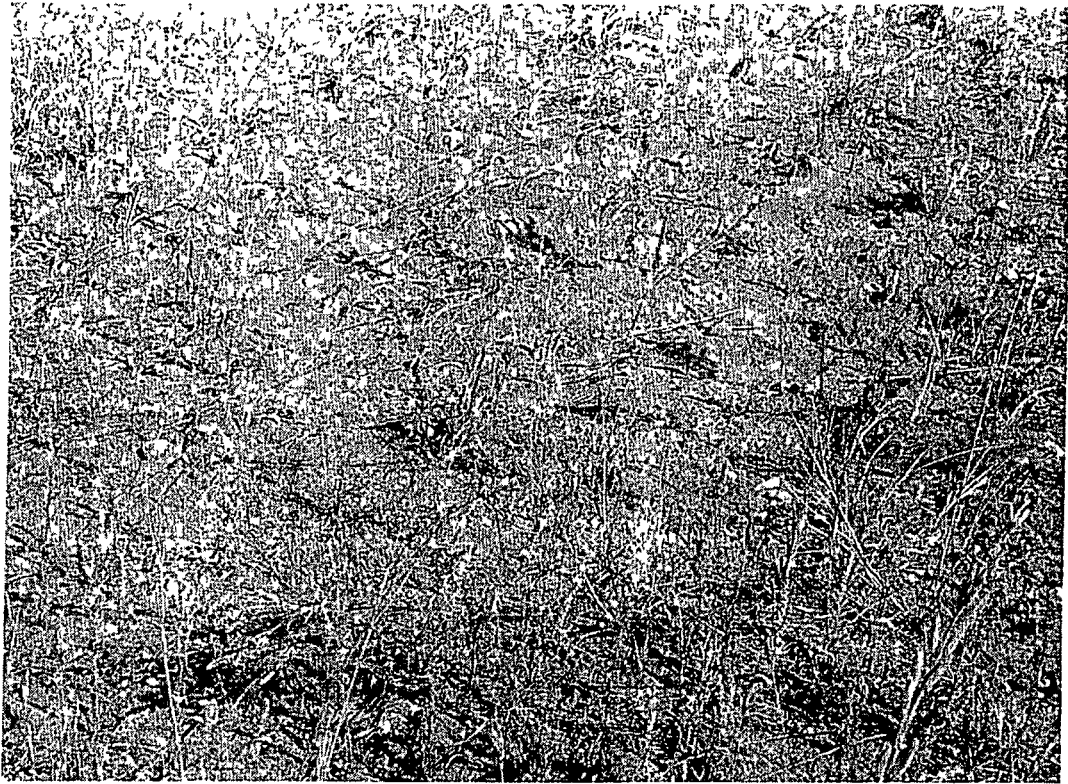
20) View of another sparsely vegetated area on surface of cap

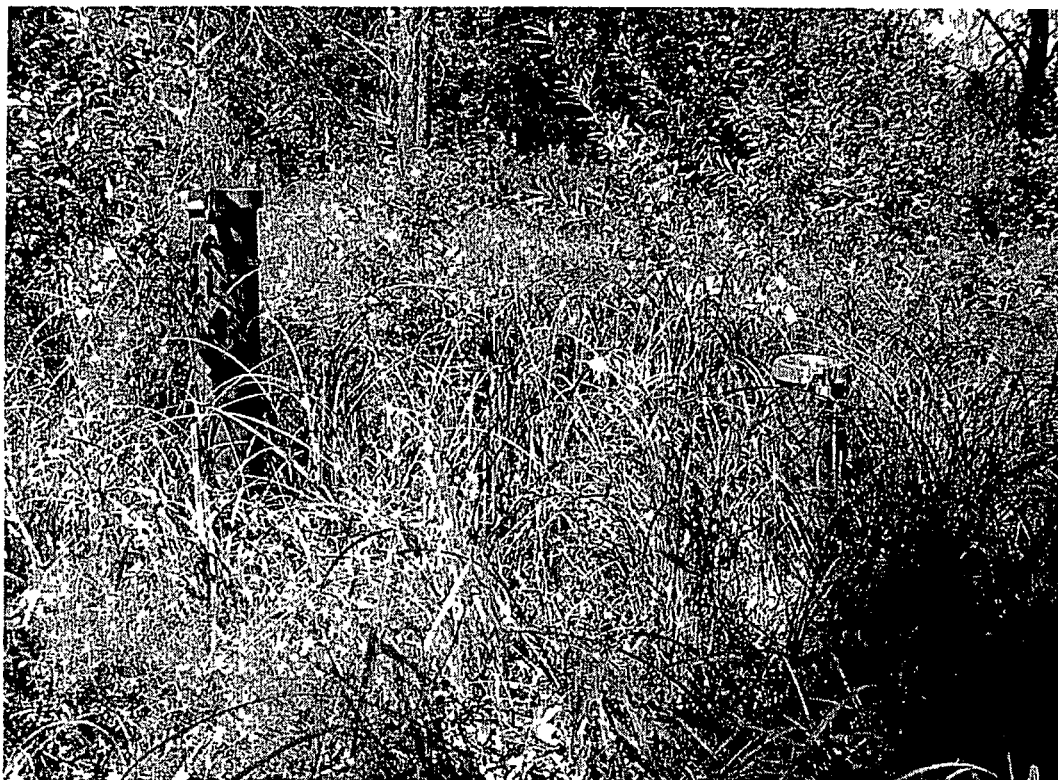
29) Monitoring wells MW-14U and MW-14L no longer in use

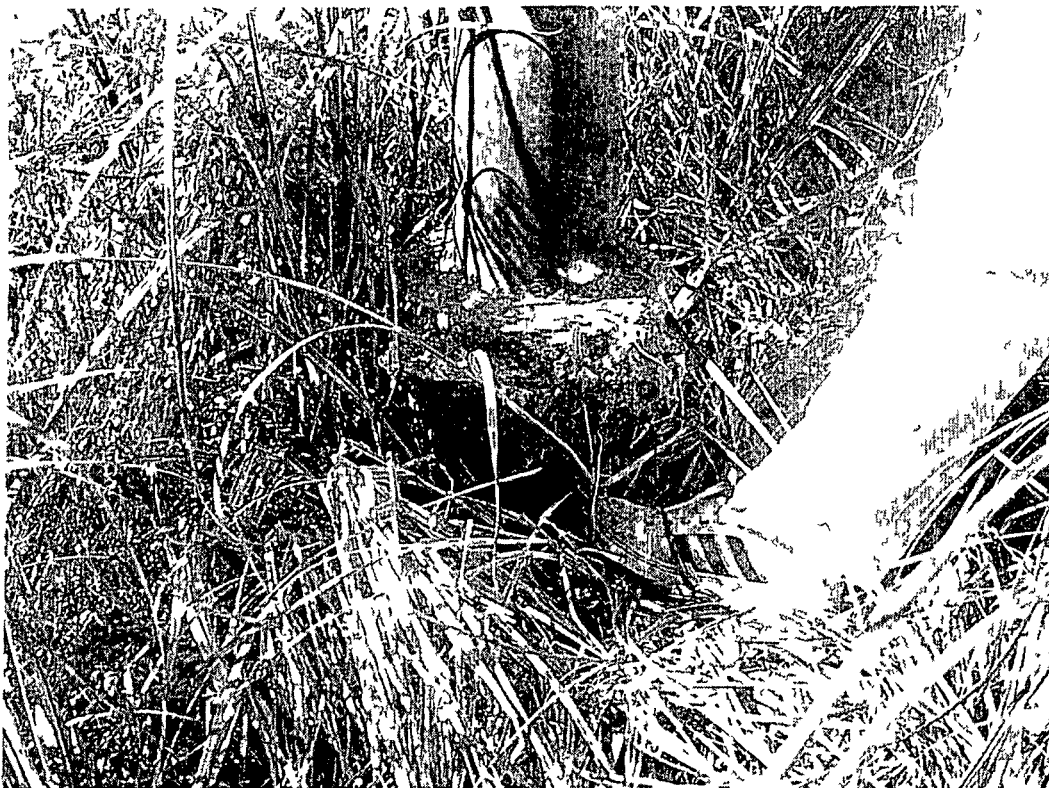
30) Monitoring well no longer in use- concrete base has heaved significantly above the ground and casing is now unstable
